# CONDITION ASSESSMENT REPORT No. 1

## Phase 1: Temporary Wood Posts

Project:Trout Creek Community CentreProject No.:TE-45355-25Address:181 Main St. W, Trout CreekPermit No.:

Client: Municipality of Powassan

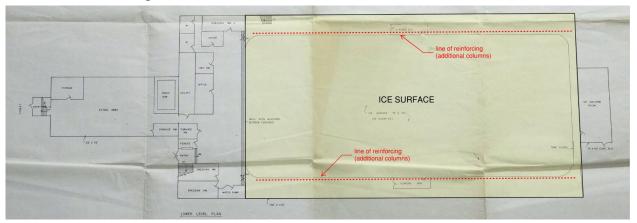
Identified on the plan above, two lines (red dashed lines) of additional columns have been added, one on either side of the primary ice surface, extending the full length of the arena.

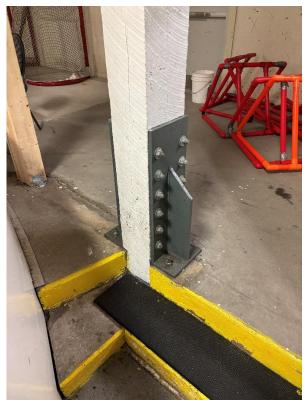
A previous engineering report identified that the existing 10x10 wood columns had deteriorated to the point that steel column bases were installed and two additional built-up wood posts were added between each original post.

Pic: Steel reinforced post base.

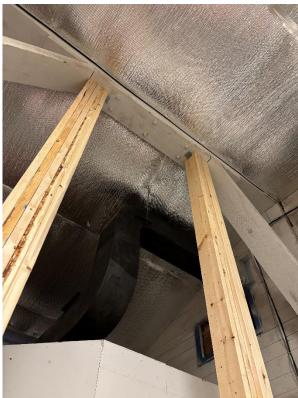
Pic: Two additional columns added.

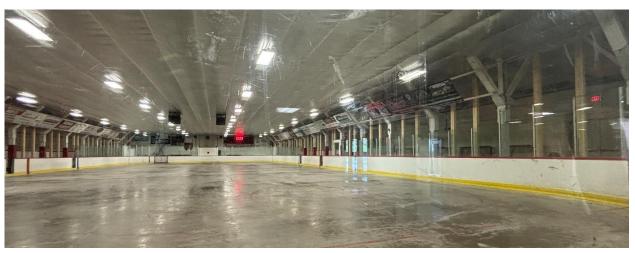
Pic: Interior of Arena – Extents of double columns.

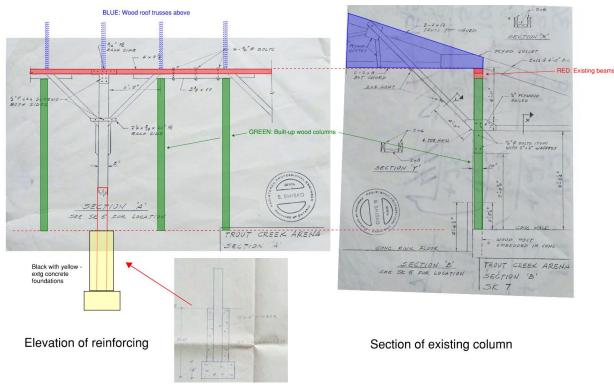
The following sketch (also attached to this report for an enlarged version) combines various drawing details to show the location of the built-up posts (green) relative to the existing wood frame. In summary, the arena is framed with double trusses located at 4'o.c. (blue) supported on a Y-braced wood frame with 10"x10" wood posts at 12'o.c. The 4' truss spacing lands trusses at each of the Y-brace locations, which is the location of the built-up wood posts that were added (green).

Based on our assessment, the existing wood frame, as reinforced with the additional built-up wood posts, is structurally adequate to support the imposed roof and snow loads.
