| Project: | Trout Creek Community Centre | Project No.: | TE-45355-25 |
| Address: | 181 Main St. W, Trout Creek | Permit No.: | |
| Client: | Municipality of Powassan | | |

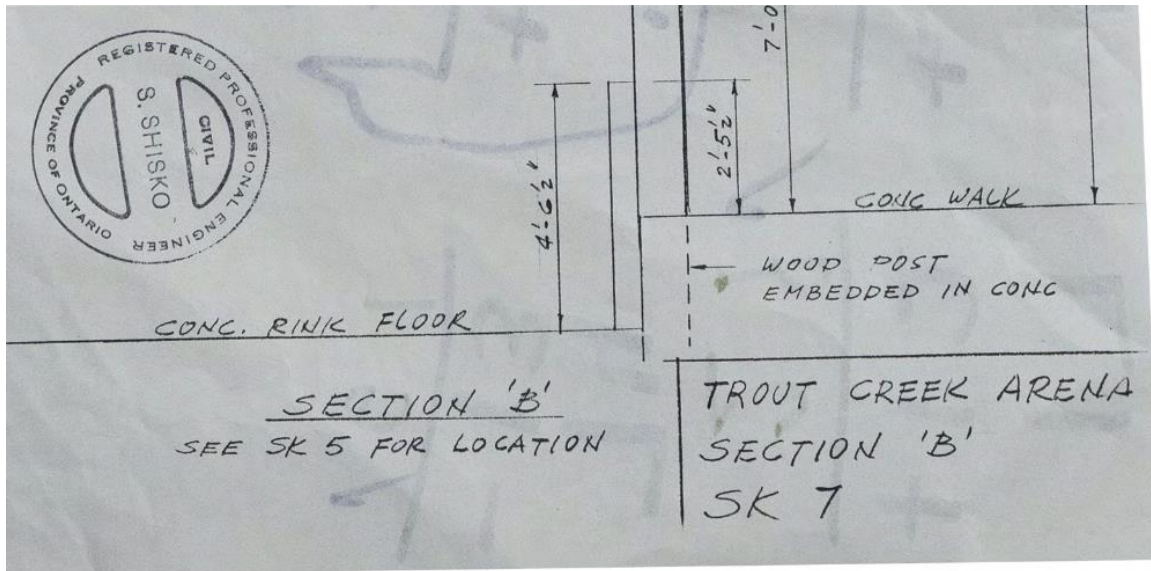
Original Drawing (Partial)

Originally embedded in the concrete foundations (refer to original partial drawing below), the wood posts have been exposed to conditions that have allowed deterioration (rot) to occur. Water, most likely sourced from the ice surface, would be trapped against the wood posts by the surrounding concrete, and with inadequate ability to dry, the moist environment has triggered deterioration.

Sawcut and remove the existing concrete slab and foundation wall / curb (+/- 12" on either side of existing embedded wood post) without affecting the rink floor slab (has chilling pipes).

Excavating down about 7', removing the existing rotted wood posts (from the steel brackets down) and replacing with a reinforced concrete footing and pier and the curb wall as needed. Assume 15M at 12" o.c. each way in the footing, 8 – 15M vertical bars with bottom hooks and 10M ties at 12" o.c. in the pier.

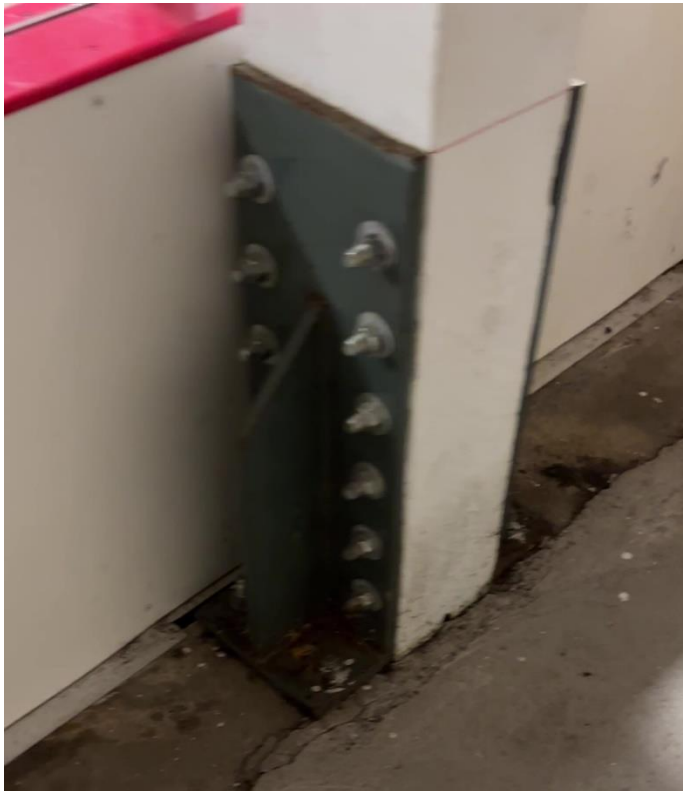
Photo: Steel Bracket Reinforcing

Recognizing that deterioration was occurring, the main posts were previously reinforced with steel brackets to transfer the loads from the posts to the concrete foundations above the deterioration. Refer to the photo below:

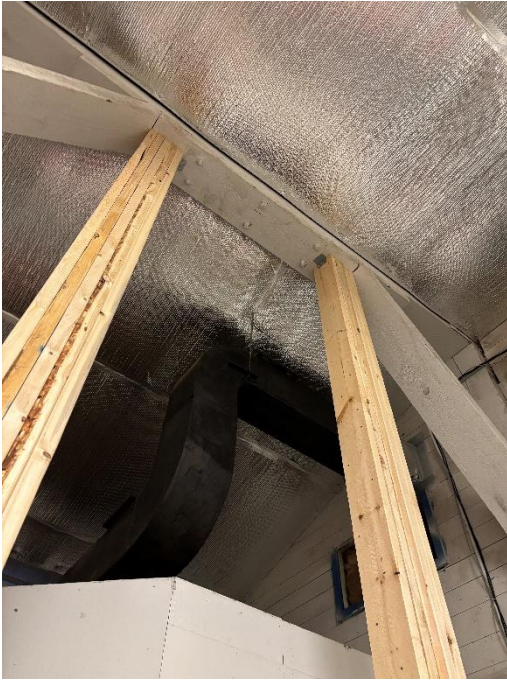
Photo: Shoring

More recent assessments have added secondary shoring to the main beam lines to further reduce the loads on the primary wood posts.

Once complete, remove the temporary shoring (pink and green posts).

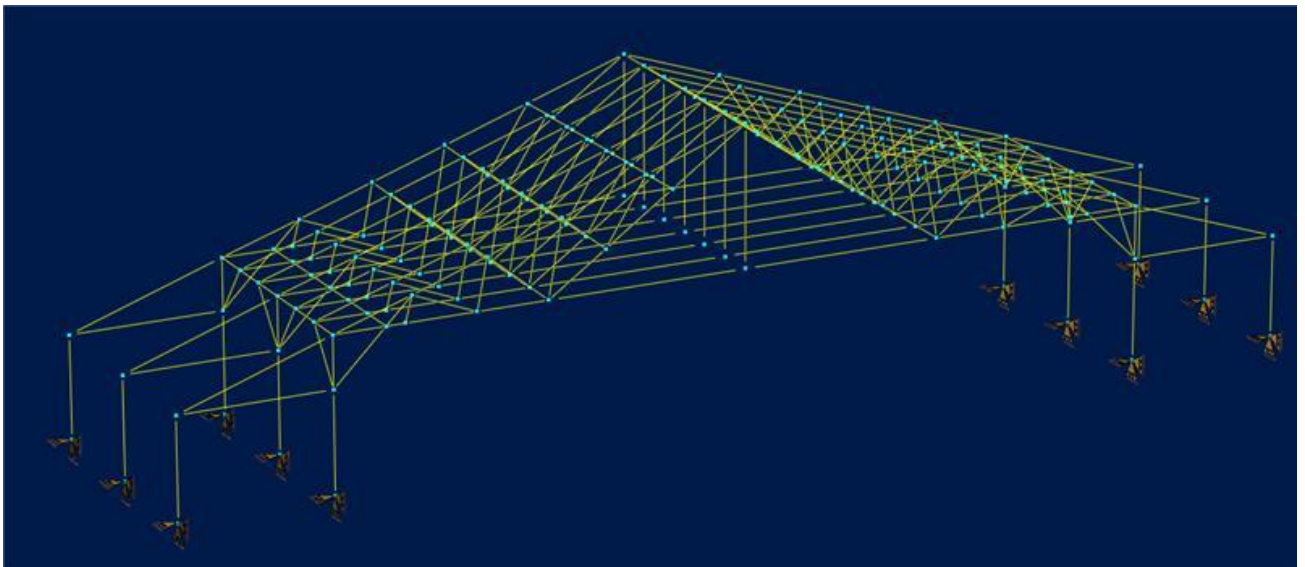
A model of the frame was constructed to verify the existing foundation loads. The image below shows the existing framing, without the additional shoring that was added.

Our analysis utilized the design snow load from the original building drawings.

Snow = 50psf (2.4kPa)

Roof = 8psf (0.4 kPa)

Note that this snow load is less than what is currently required by code. Upgrading to current codes will likely require reinforcement of the existing roof trusses (not part of this scope).
