| Project: | Trout Creek Community Centre | Project No.: | TE-45355-25 |
| Address: | 181 Main St. W, Trout Creek | Permit No.: | |
| Client: | Municipality of Powassan | | |

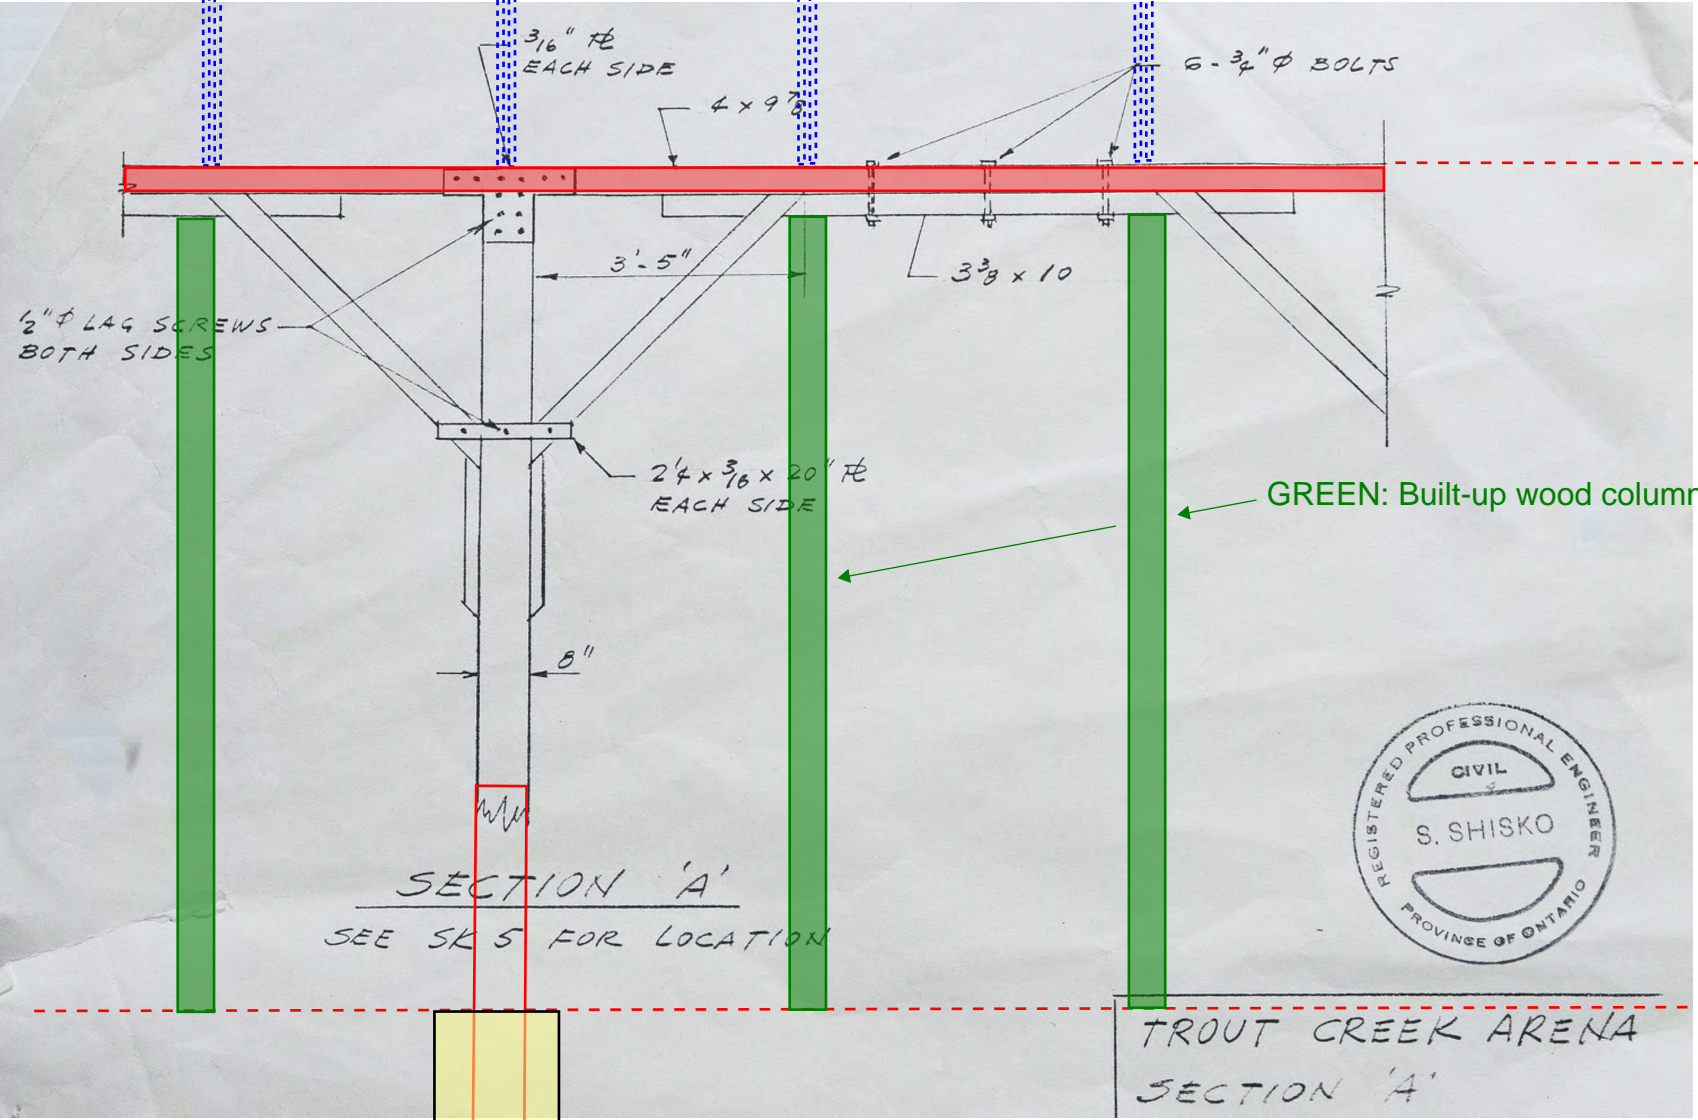
BLUE: Wood roof trusses above

GREEN: Built-up wood columns

RED: Existing beams

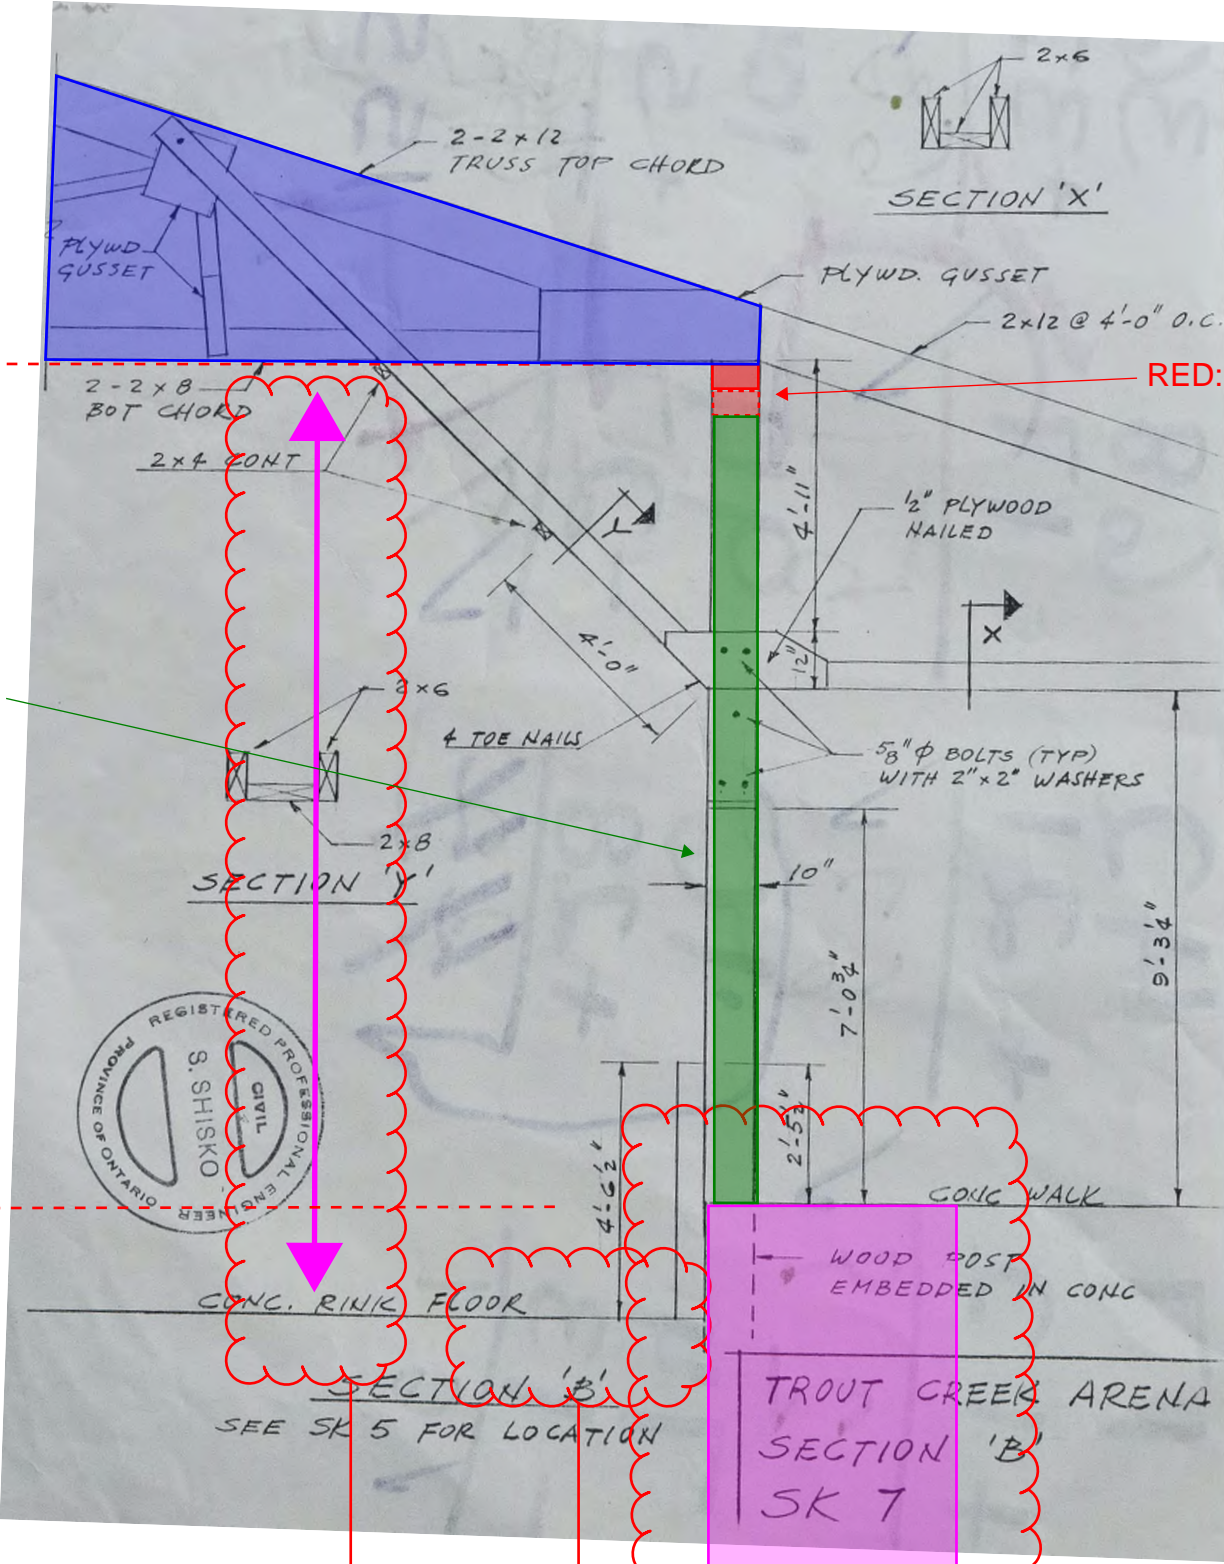
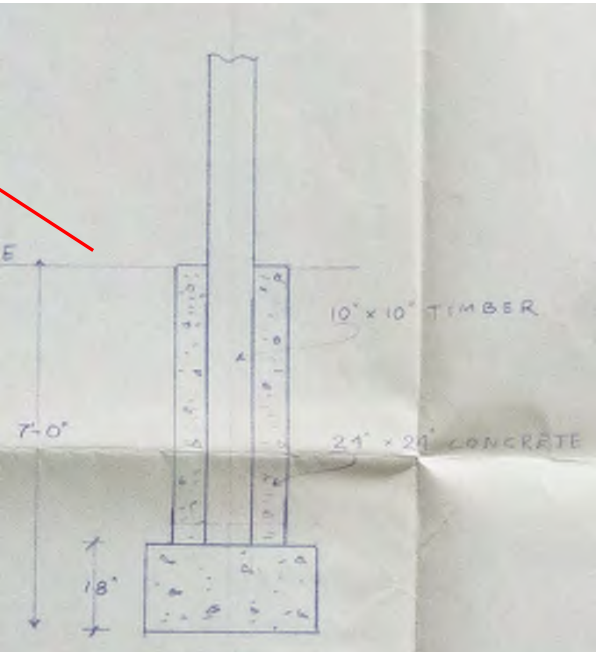
Foundation Remedial Detail

Temporary shoring post to be added by contractor

Section of existing column

This slab NOT to be touched

Black with yellow - extg concrete foundations

Elevation of extg shoring

Excavating down about 7', removing the existing rotted wood posts (from the steel brackets down) and replacing with a reinforced concrete footing and pier and the curb wall as needed. Assume 15M at 12" o.c. each way in the footing, 8 – 15M vertical bars with bottom hooks and 10M ties at 12" o.c. in the pier.

sawcut and remove extg slab, excavate, new concrete pier
